OPEN CARTON AUDIT REPORT

To : MARTIN SVENSSON Home - US OFFICE
Cc : NGU LAM VIET Furniture - Viet Nam
From : Origins Sourcing Company - VN RO.
Auditor : Bao Tu - San Huynh
Item No. : 830223
PO#/Cutting : 1080
Date Inspection : Jun 27th, 2023

#ITEM	PRODUCTS DESCRIPTION	Q'TY SHIPPED	INSPECTED Q'TY	ACCEPTED
830223	Coffee Table - White	78	3	3

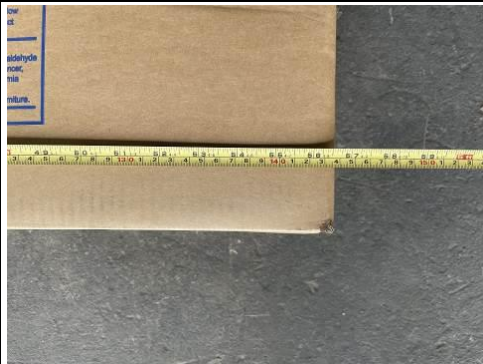
1440mmL

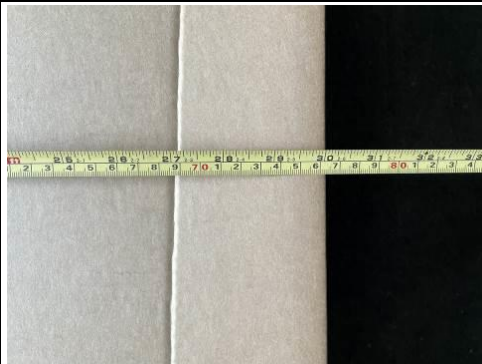
760mmW

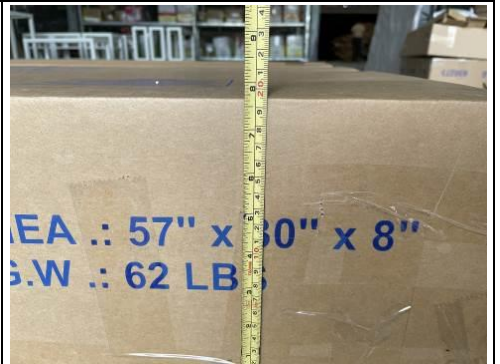
200mmH

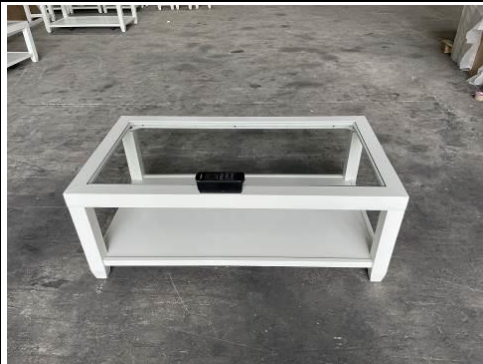
Sheen measurement-OK

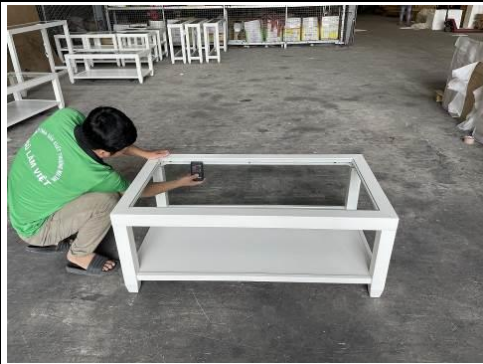
MC checking-OK

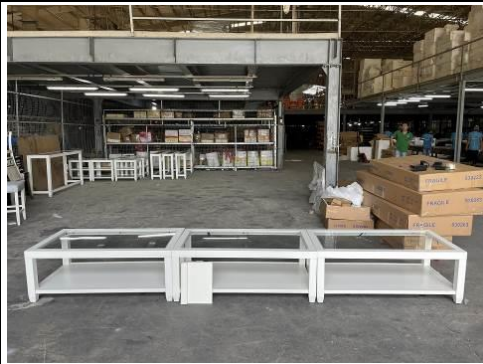
Color checking with MCP
