OPEN CARTON AUDIT REPORT

To : MARTIN SVENSSON Home - US OFFICE
Cc : NGU LAM VIET Furniture - Viet Nam
From : Origins Sourcing Company - VN RO.
Auditor : Bao Tu - San Huynh
Item No. : 830223
PO#/Cutting : 1080
Date Inspection : Jun 27th, 2023

#ITEM	PRODUCTS DESCRIPTION	Q'TY SHIPPED	INSPECTED Q'TY	ACCEPTED
830223	Coffee Table - White	78	3	3

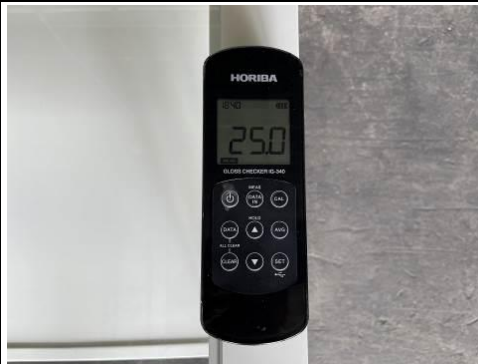
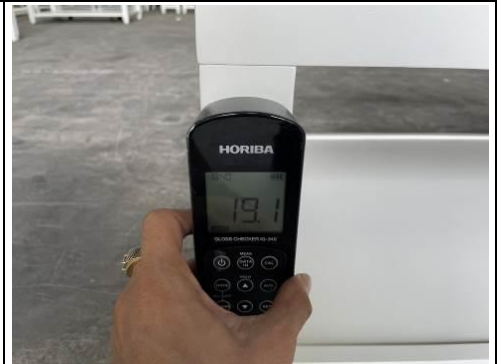
Sheen measurement-OK

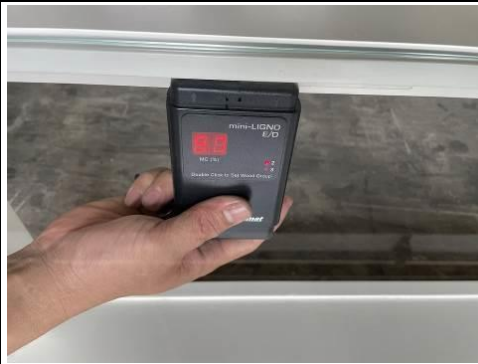
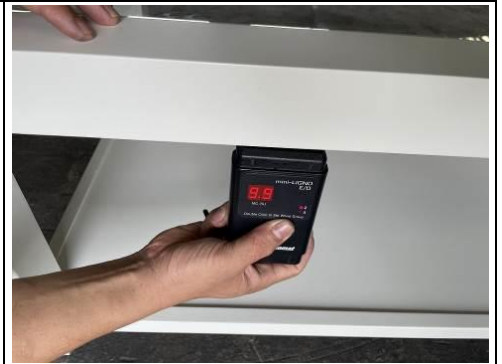
MC checking-OK

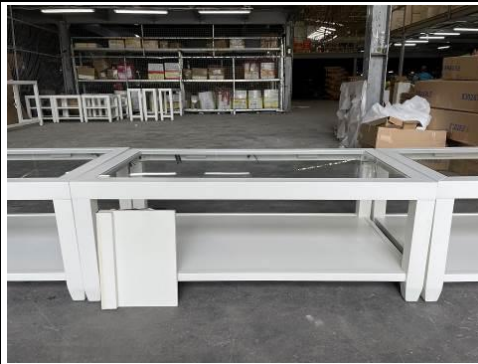
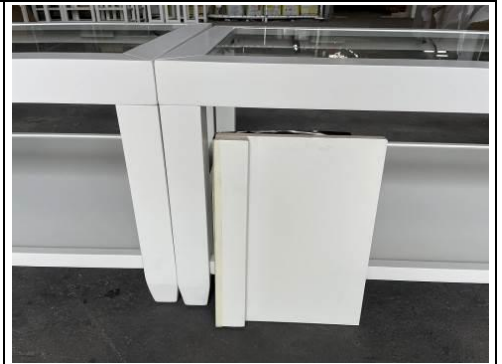
Color checking with MCP
